Electric Heating Systems For Combatting Icing Problems On Metal Roofs

BY JAMES BUSKA, WAYNE TOBIASSON, ALAN GRETOREX AND WILLIAM FYALL

ICICLES AND ICE DAMS MAY DEVELOP ON METAL ROOFS THAT DRAIN TO COLD EAVES. MELTWATER that backs up behind such icings may leak into buildings, causing serious damage. Large icings are also a safety hazard. Electric heating systems may be needed to provide a path for meltwater to drain safely off such roofs.

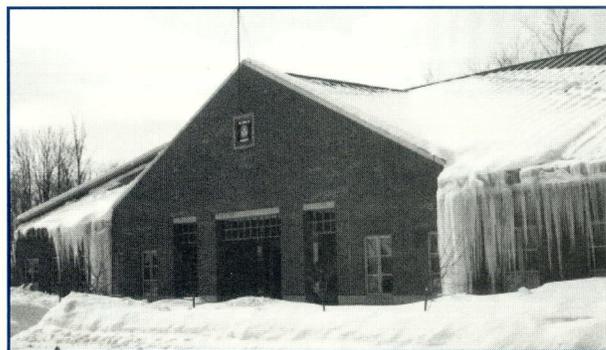
Figure 2. Large ice dams and icicles form where the gable parapet ends at the bottom of valleys.

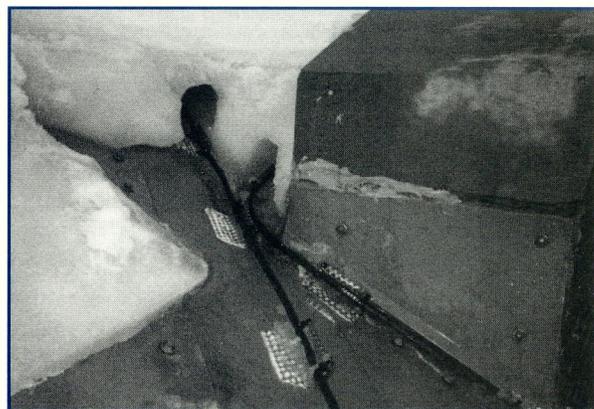
Figure 8. Heaters provide melt paths through snow and ice for meltwater to drain off the roof. Some ice was removed to expose these paths for this photo.

All six electric heater systems provided melt paths through the ice dams in their valleys and prevented ponding from occurring there (Figure 8). In most cases, this greatly reduced the size of the icings and the risk of roof leaks. Roof leaks were reported under control valleys that winter but not under the heated valleys.

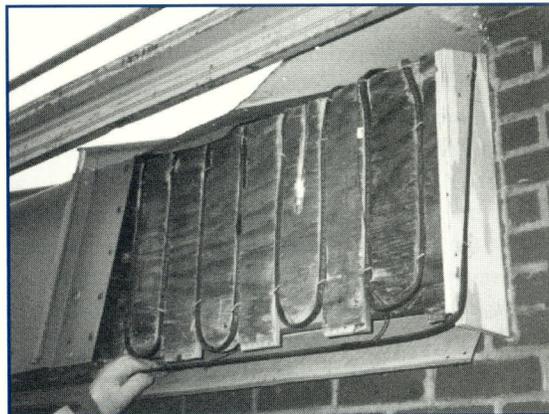
Figure 11. Heater laid in channels routed in the plywood sheathing behind the fascia metal.

For aesthetic and thermal efficiency reasons, some heaters were placed behind the metal fascia. On two buildings, plywood sheathing behind the metal fascia was routed out and the heater carefully stapled in these channels (*Figure 11*). Upper loops from the heater's fascia runs were held tightly to the sloped metal roofing. The end of the heater ran horizontally at the bottom of the fascia to warm the drip edge. When the metal roofing was replaced, these two buildings had all their heaters located below the metal roofing. This was difficult to do but it was tried for the aesthetic, maintenance and thermal efficiency benefits gained.

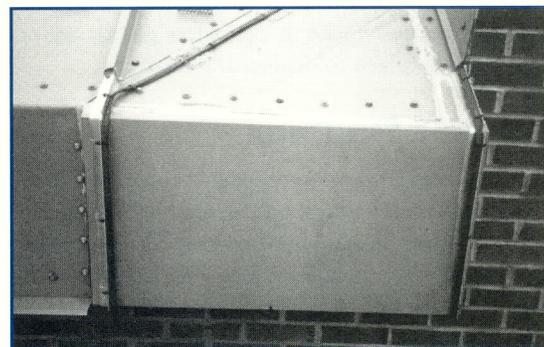
Figure 13. False closed-top fascia installed over heater shown in Figure 12. Note heated vertical baffles (water diverters) at each end.

Heater runs on the fascias of three buildings were looped over butterfly clips mechanically attached to the metal fascia (*Figure 12*) and then covered with a false fascia, either closed at the top as shown in *Figure 13*

(Buildings 10150 NW and 10210) or open at the top like a chimney (Building 10230). Installation of heaters and false fascias was much easier than placing heaters behind existing fascias. False fascias also allow for easier access if repairs are necessary. Heated water diverters were used on all roofs to direct meltwater flow over the heated fascia and drip edge. A diverter is shown at each end of the false fascia in *Figure 13*. Diverters were able to prevent icings just beyond heated portions of fascias.

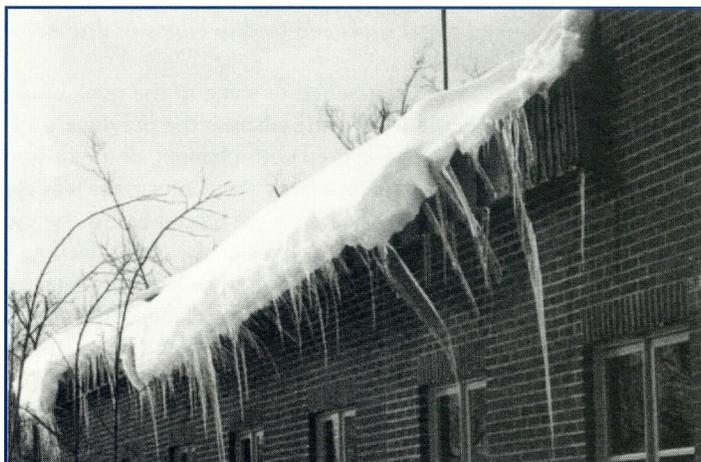
Figure 15. Icings forming on a creeping, overhanging mass of snow and ice, bypass the heated fascia on this building. Note exposed heaters at near end of fascia.

- When snow and ice protrude beyond the eaves due to creep, meltwater will run out in it and on its underside, creating large icings there until the extra weight causes the mass to break away. Snow guards are needed to hold the snow on the roof to avoid this problem and to protect the heaters.
